**Flood Control Project Maintenance  
Levee Inspections**

**Fall 2014 Levee Maintenance Deficiency Summary Report**

**Sutter Maintenance Yard Maintenance Area 0016**

Waterway			Bank	Unit Miles
Unit No. 01 Feather River			Right	4.06
	Spring (March - May)	Summer (June - August)	(September - November) Fall	Winter (December - February)
Unit Maintenance Rating (Fall Only)			<b>A</b>	
Date of Inspection	03/18/2014 - 03/18/2014		11/19/2014 - 11/19/2014	
DWR Inspector	Matthew Hoffman		Matthew Hoffman	
Accompanied By	Jason Cooper Sutter Maintenance Yard		Jason Cooper Sutter Maintenance Yard

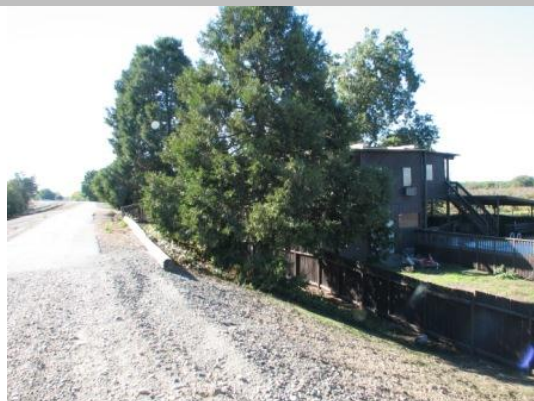
Photo 1 of 1 : FA\_2014\_MA0016\_302\_7\_20141110\_00002.jpg

LM Start	0.45	Rating **	U	Issue No.	7
LM End	0.49	Issue Type +	En	Location *	LS
Category	Earthen Levee			GPS Latitude/Longitude	
				Start	End
Item	Encroachments			39.262213 °	39.262825 °
				-121.636545 °	-121.636430 °
DWR ID	DWR_MA0016_01_s _ 2012_7				
Action/Comments					
Building

Levee mile 0.49. This photo shows the building and landscaping on the landside slope and toe.

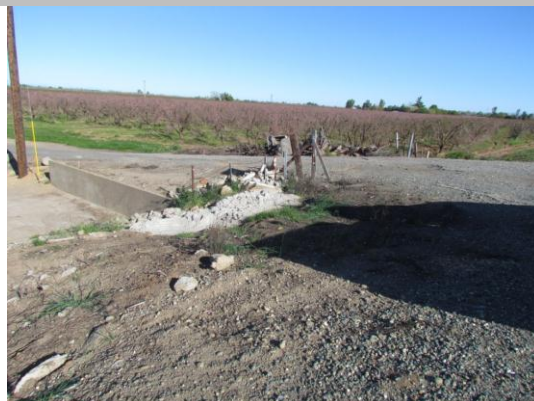
Photo 1 of 1 : FA\_2014\_MA0016\_302\_11\_20141110\_00003.jpg

LM Start	1.16	Rating **	U	Issue No.	11
LM End	1.16	Issue Type +	En	Location *	LS
Category	Earthen Levee			GPS Latitude/Longitude	
				Start	End
Item	Encroachments			39.272228 °	39.272228 °
				-121.633721 °	-121.633721 °
DWR ID	DWR_MA0016_01_s _ 2014_11				
Action/Comments					
Debris					
Inspector Comments: Concrete on landward levee slope. Spring 2014.

This photo was taken from the levee crown facing north looking at leftover concrete poured on the landward slope. Spring 2014.

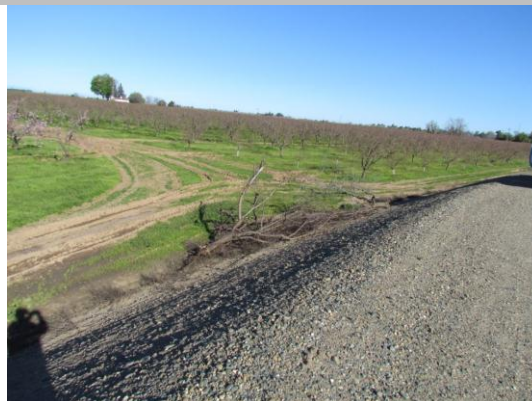
Photo 1 of 1 : FA\_2014\_MA0016\_302\_12\_20141110\_00004.jpg

LM Start	1.64	Rating **	M	Issue No.	12
LM End	1.64	Issue Type +	En	Location *	LS
Category	Earthen Levee			GPS Latitude/Longitude	
				Start	End
Item	Encroachments			39.278978 °	39.278978 °
				-121.633278 °	-121.633278 °
DWR ID	DWR_MA0016_01_s_2014_12				
Action/Comments					
Prunings					
Inspector Comments: Dead Prune trees placed on landward levee slope. Spring 2014.

This photo was taken from the levee crown facing north looking at prunings and a dead tree placed at the landward levee toe. Spring 2014.

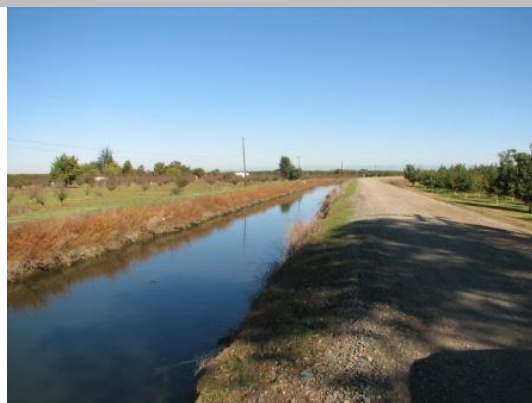
Photo 1 of 2 : FA\_2014\_MA0016\_302\_14\_20141110\_00005.jpg

LM Start	2.85	Rating **	M	Issue No.	14
LM End	3.08	Issue Type +	En	Location *	LS
Category	Earthen Levee			GPS Latitude/Longitude	
				Start	End
Item	Encroachments			39.293675 °	39.296748 °
				-121.636615 °	-121.638192 °
DWR ID	DWR_MA0016_01_s_2012_14				
Action/Comments					
Ditch

Agricultural ditch land side slope and toe.

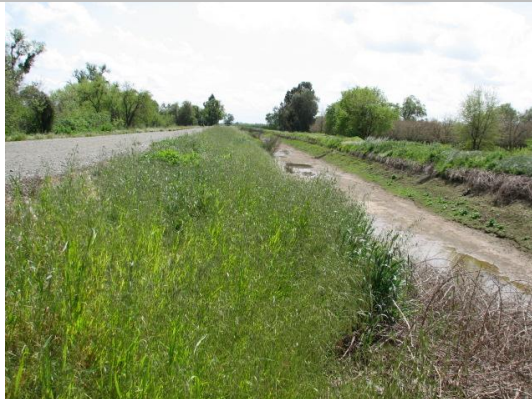
Photo 2 of 2 : FA\_2014\_MA0016\_302\_14\_20141110\_00006.jpg

LM Start	2.85	Rating **	M	Issue No.	14 (cont)	
LM End	3.08	Issue Type +	En	Location *	LS	
Category	Earthen Levee			GPS Latitude/Longitude		
				Start		End
Item	Encroachments			39.293675 °		39.296748 °
				-121.636615 °		-121.638192 °
DWR ID	DWR_MA0016_01_s_2012_14					
Action/Comments						
Ditch

Land side ditch levee mile 3.08.
